Final Report Narrative

Project Name: Upper Genesee River Streambank Stabilization – Caneadea, NY

Project Number: WS06-16-05

Project Sponsor: Center for Environmental Initiatives (dba Genesee RiverWatch)

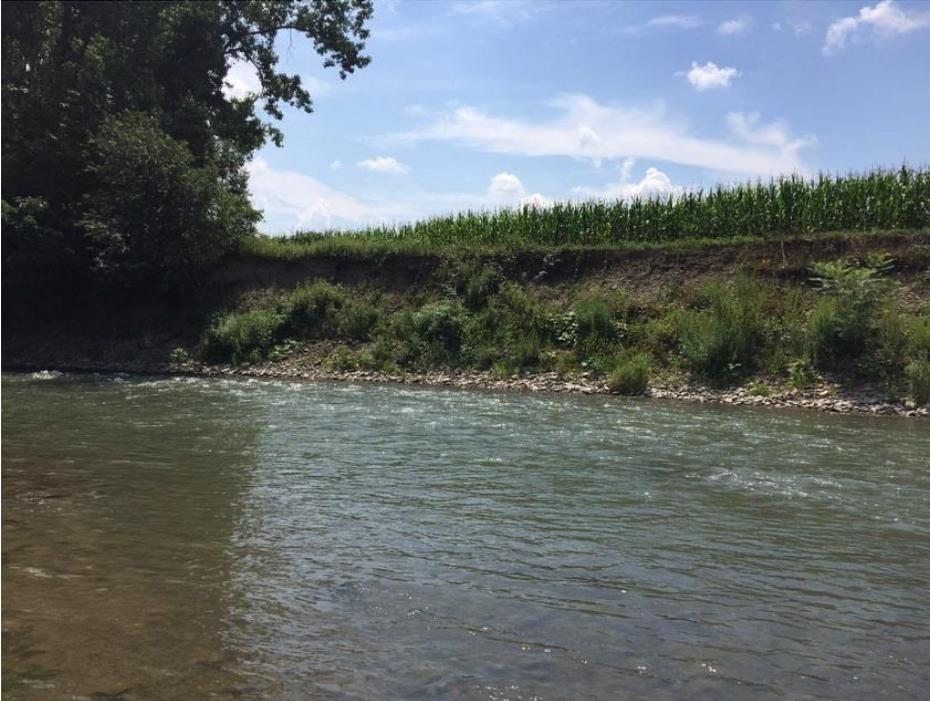
Before Construction, Upstream End, 2016

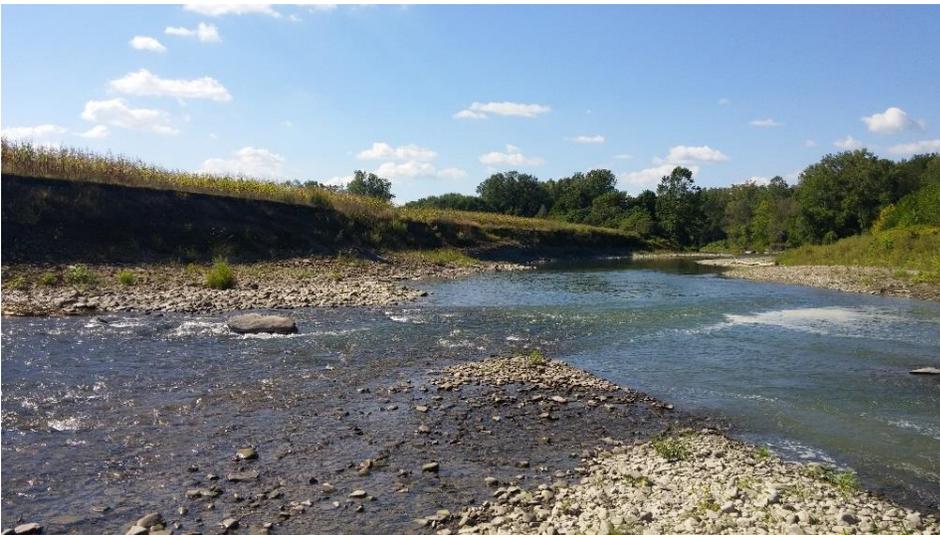
Before Construction, Whole Project Site, 2016

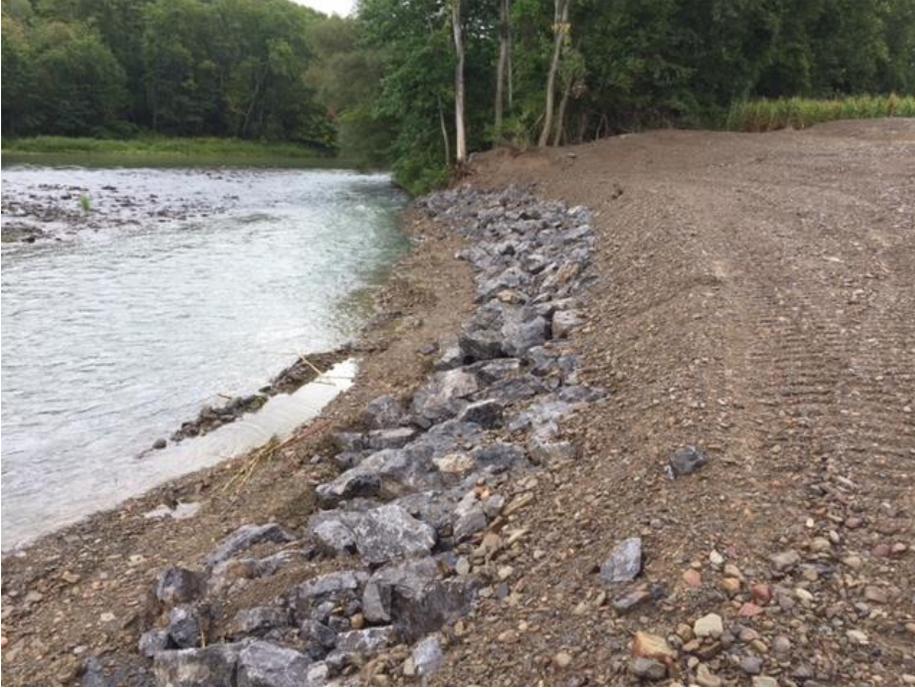
During Construction, Upstream End, Summer 2017

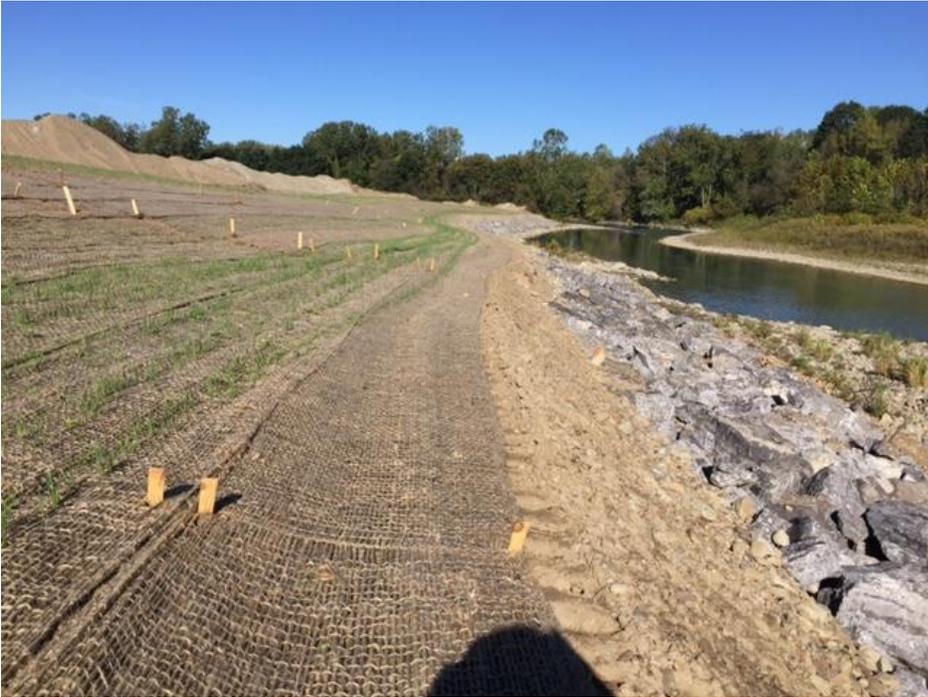
During Construction, Whole Project Site, Summer 2017

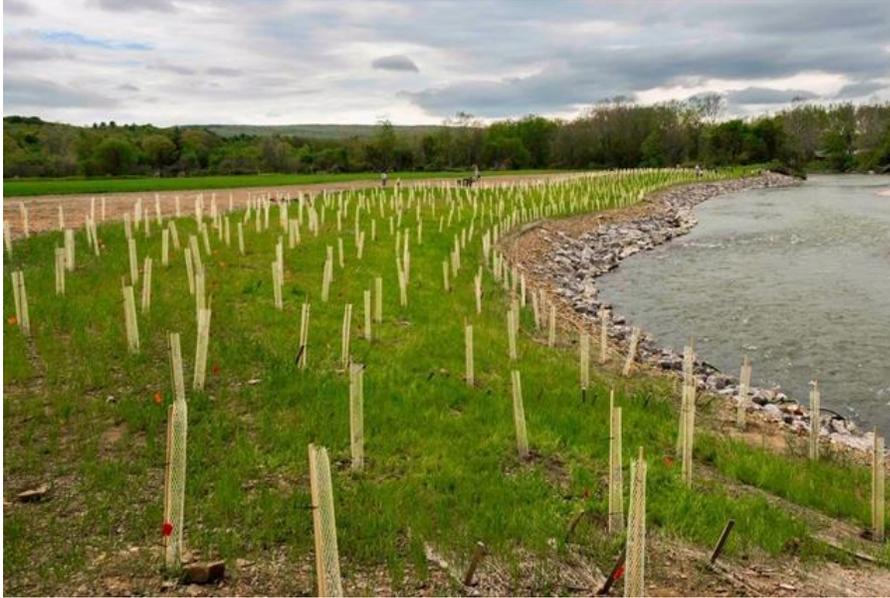
During Construction, Tree Planting, Spring 2018

Once the bank was stabilized with rip rap, the riparian buffer was graded and seeded in the fall. In the spring of the next year (2018) we were able to attract 65 volunteers to help us plant the 1,000 bare-root seedlings necessary to complete the restoration.

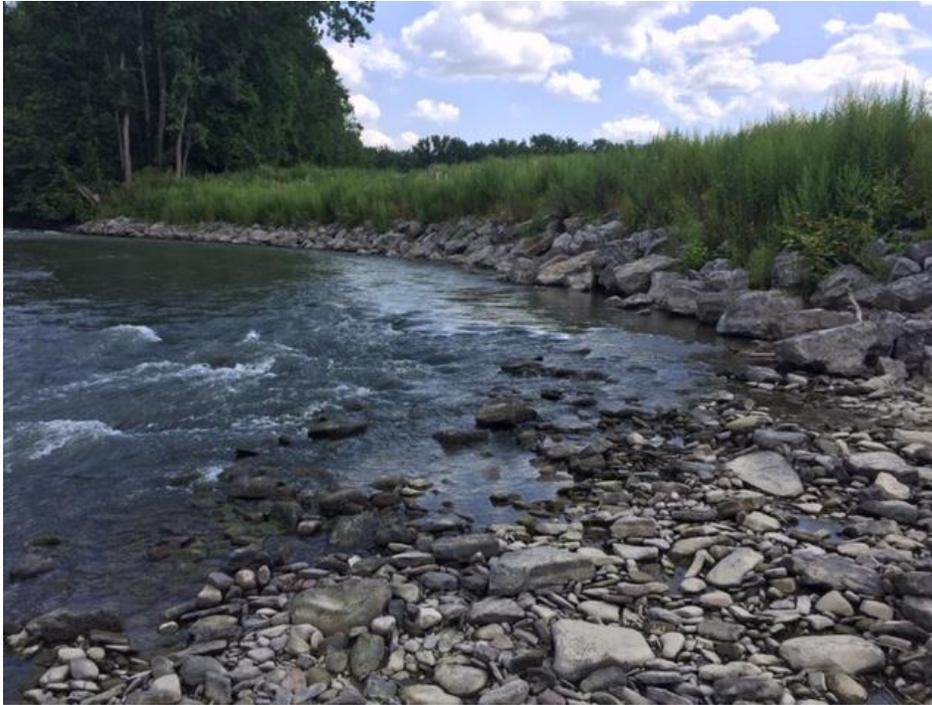
After Construction, Upstream End, August 2019

The landowner has also agreed to conduct post-restoration maintenance and monitoring to ensure proper plant growth and stability of the restoration. Subsequent site inspections since then have shown the seedling survival rate to be around 40% as we expected. The trees and shrubs have grown nicely as has the riparian mix. The pictures provided show that well.

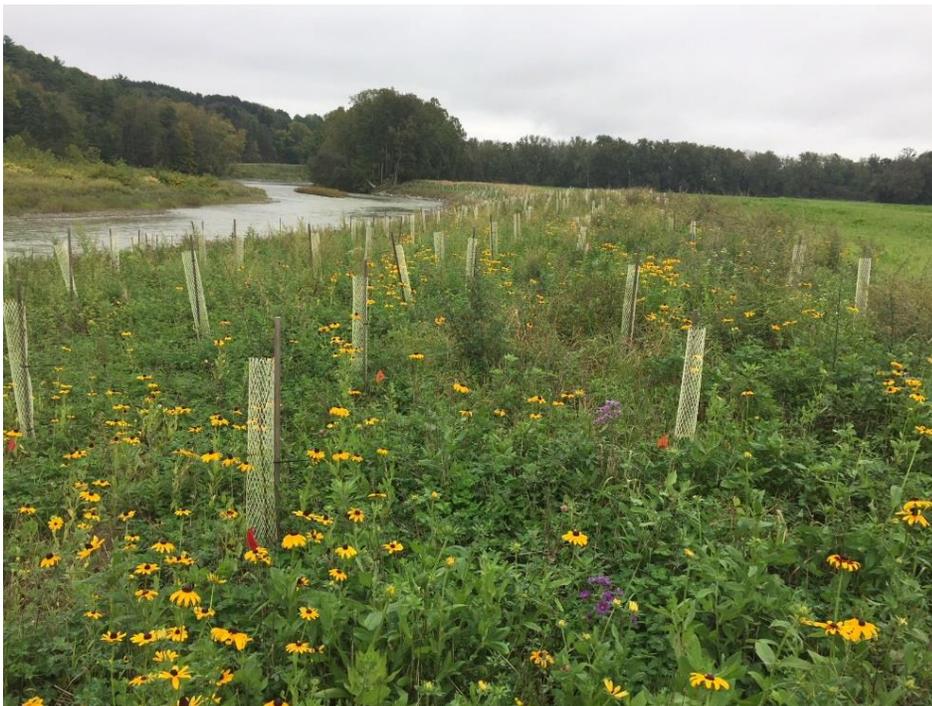
After Construction, Whole Project Site, Fall 2018

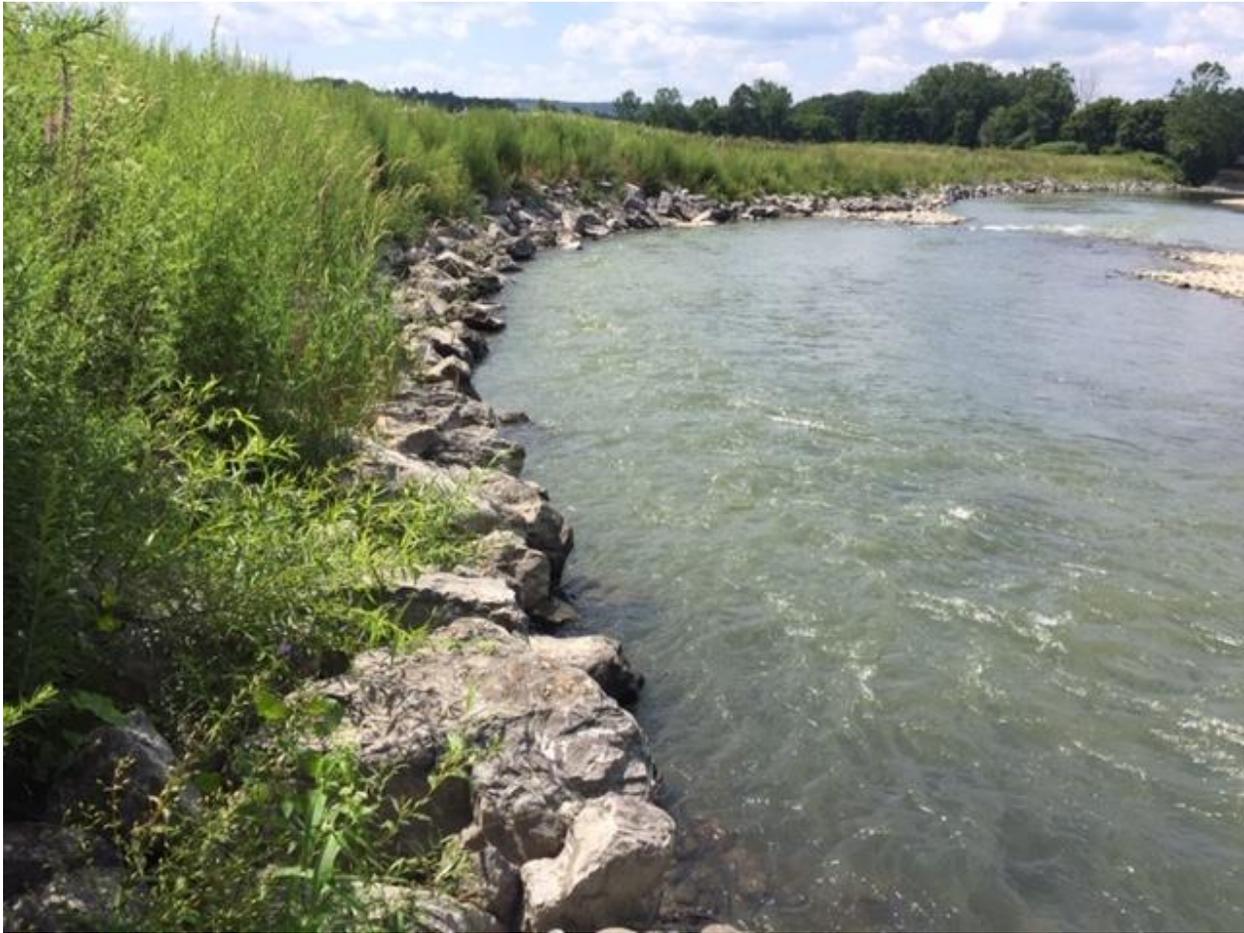
After Construction, Whole Project Site, August 2019

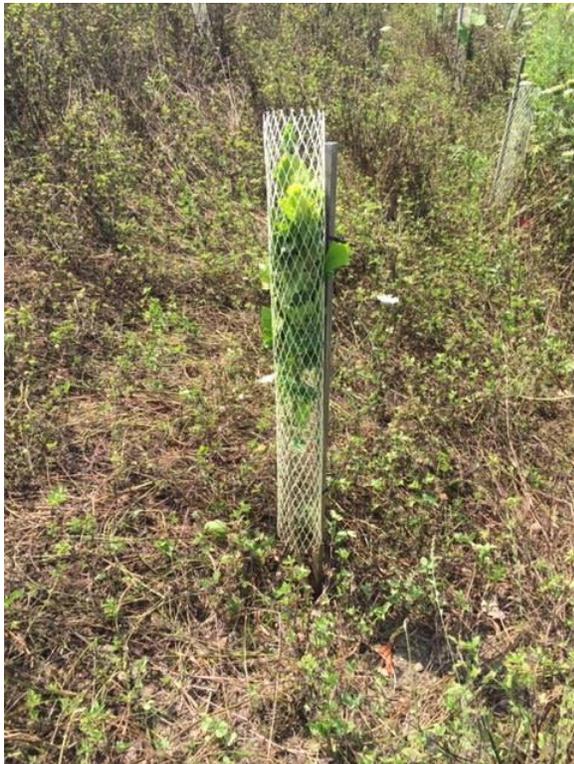
Seedling with Tube Protector

Creative or Innovative Activities Attempted: During the planting of the bare root seedlings we ran into an unexpected problem associated with sliding the protection tube over the planted seedling. The branches of the seedlings would get caught in the mesh of the tube. We fashioned a device out of cardboard (the only material on site that would work) to allow the tube to be easily slid over the seedling. This significantly sped up the process.
